**Model: NDP-25BVH-PP**  
**Part # 854223 - NPT**  
**Part # 854225- Flange**

Parts Breakdown

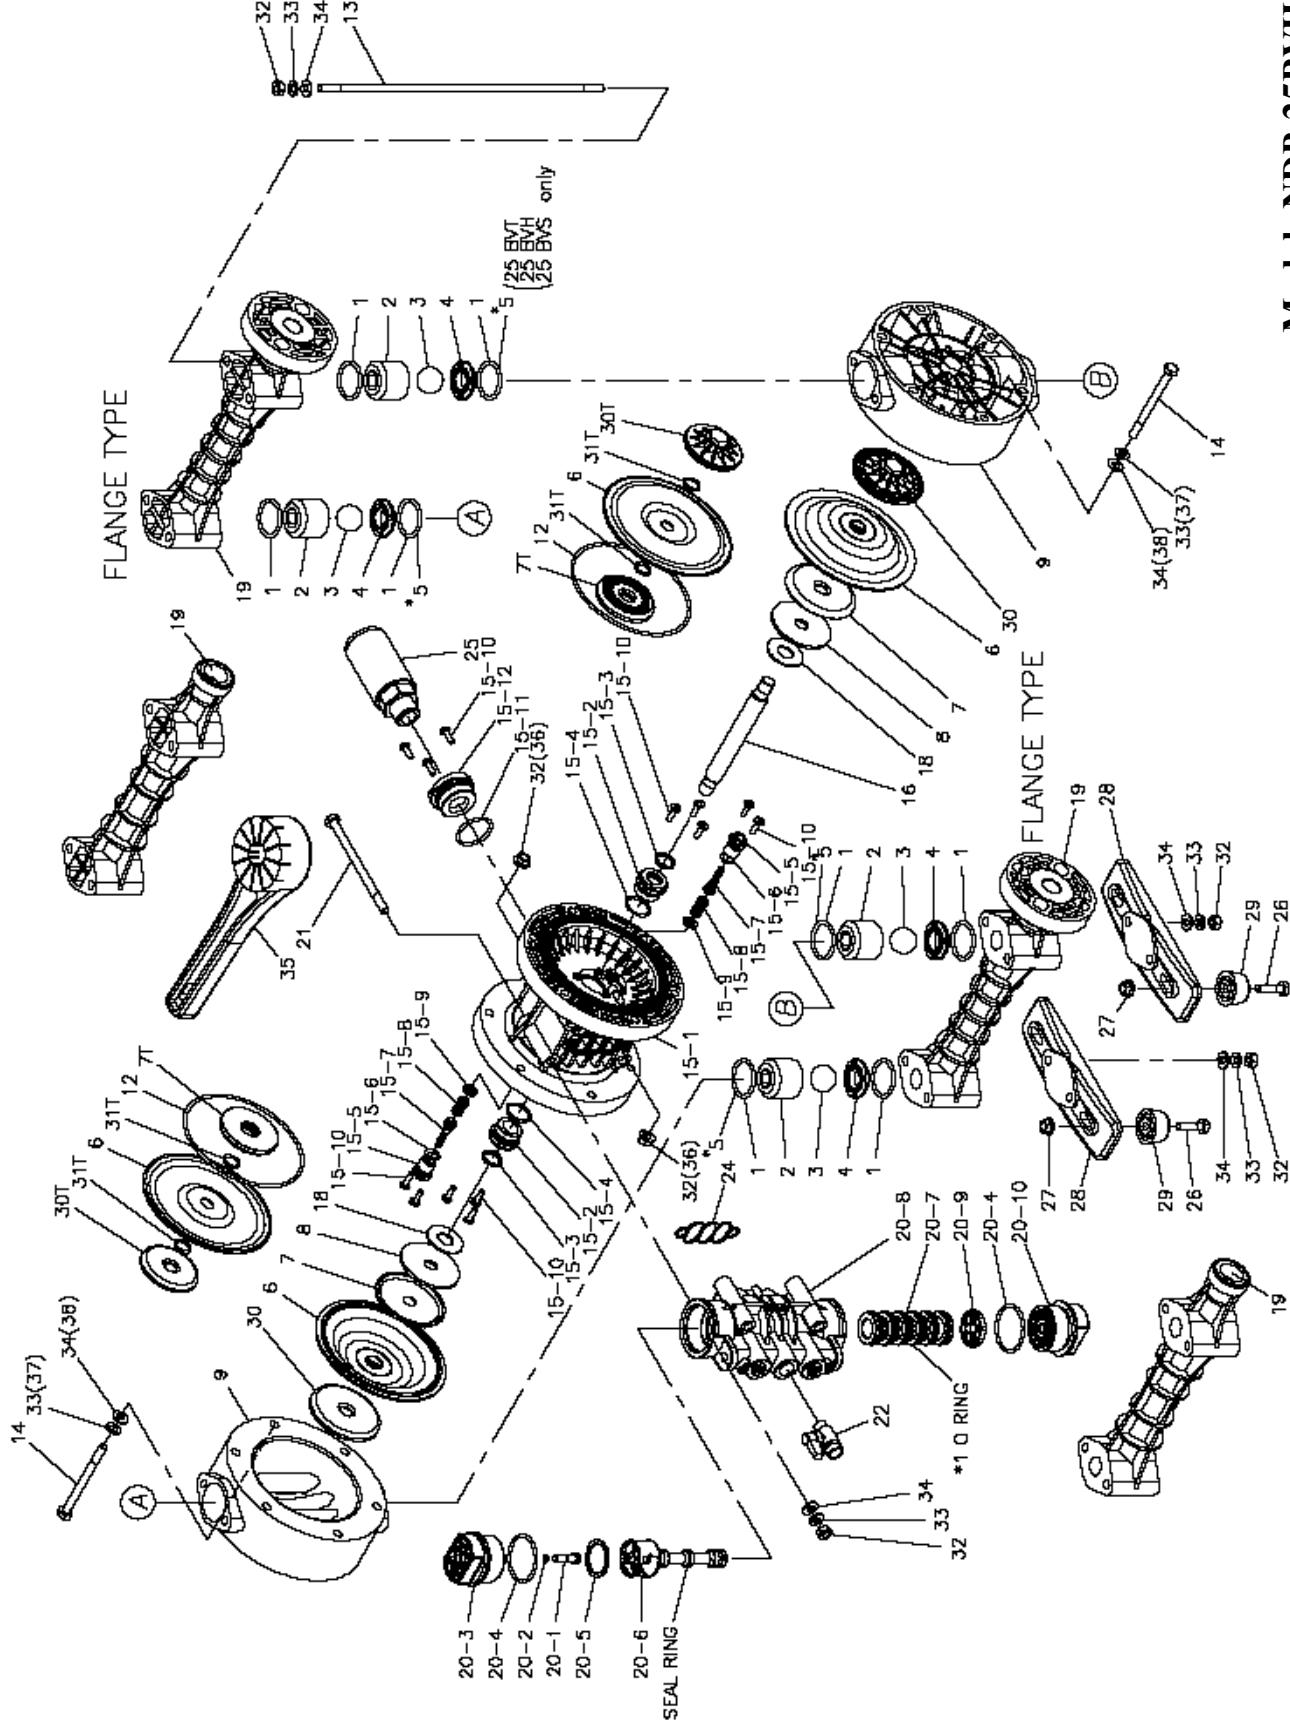
Reference			
No.	Description	Q'ty	Part No.
1	O-ring	4	643042
2	Valve Stopper	4	780141
3	Ball	4	773127
4	Valve Seat	4	780139
5	O-ring	4	643041
6	Diaphragm	2	771363
7	Center Disk	2	716258
7T	N/A	-	-
8	Plain Washer	2	716259
9	Out Chamber	2	780136
12	O-ring	2	640154
13	Tie Rod	4	710207
14	Bolt	12	683541
15	Body Assembly	1	804604
16	Center Rod	1	710271
18	Cushion	2	771054
19	Manifold - NPT	2	780057
19	Manifold - Flange	2	780212
20	Valve Body Assembly	1	804608
21	Bolt	4	686031
22	Ball Valve	1	682772
24	Gasket	1	772848
25	Silencer	1	804697
26	Bolt	4	621153
27	Nut with Flange	4	686032
28	Pump Base	2	771749
29	Cushion	4	770551
30	Center Disk	2	780127
30T	N/A	-	-
31T	N/A	-	-
32	Nut	12	683635
33	Spring Lock Washer	12	681300
34	Plain Washer	12	631329
35	Accessory Tool	2	771244
36	Nut with Flange	12	686033
37	Spring Lock Washer	12	680257
38	Plain Washer	12	631330

Body Assembly - 804604			
Reference			
No.	Description	Q'ty	Part No.
15-1	Body	1	772929
15-2	Throat Bearing	2	772931
15-3	Packing	2	685414
15-4	O-ring	2	685276
15-5	Valve Seat	2	772932
15-6	O-ring	2	640009
15-7	Pilot Valve Assembly	2	802360
15-8	Spring	2	708666
15-9	Spring Seat	2	772948
15-10	Tapping Screw	13	686030
15-11	O-ring	1	640132
15-12	Bushing	1	772933

Valve Body Assembly - 804608			
Reference			
No.	Description	Q'ty	Part No.
20-1	Rest Button	1	772991
20-2	O-ring	1	640002
20-3	Cap A	1	772946
20-4	O-ring	2	640043
20-5	Packing	1	771241
20-6	C Spool Valve Assy.	1	802400
20-6 seal	Seal Ring	5	771053
20-7	Sleeve Assembly	1	804609
20-7-*1	O-ring	6	686029
20-8	Valve Body Assembly	1	832903
20-9	Cushion	1	771914
20-10	Cap B	1	772947

Repair Kits			
K25-VH-PP Liquid Side Repair Kit			
No.	Description	Q'ty	Part No.
1	O-ring	4	643042
3	Ball	4	773127
5	O-ring	4	643041
6	Diaphragm	2	771363
12	O-ring	2	640154
K225-AP Air Side Repair Kit			
18	Cushion	2	771054
15-2	Throat Bearing	2	772931
15-3	Packing	2	685414
15-4	O-ring	2	685276
15-5	Valve Seat	2	772932
15-6	O-ring	2	640009
15-7	Pilot Valve Assembly	2	802360
15-8	Spring	2	708666
15-9	Spring Seat	2	772948
15-11	O-ring	1	640132
15-12	Bushing	1	772933
20-2	O-ring	1	640002
20-4	O-ring	2	640043
20-5	Packing	1	771241
20-6 seal	Seal Ring	5	771053
20-7-*1	O-ring	6	686029
20-9	Cushion	1	771914
